TAHAROA

Inspection and Audit of Port Taharoa Operations

Date: 16 July 2015

Our Reference: CW/812/R01/NC/SLB

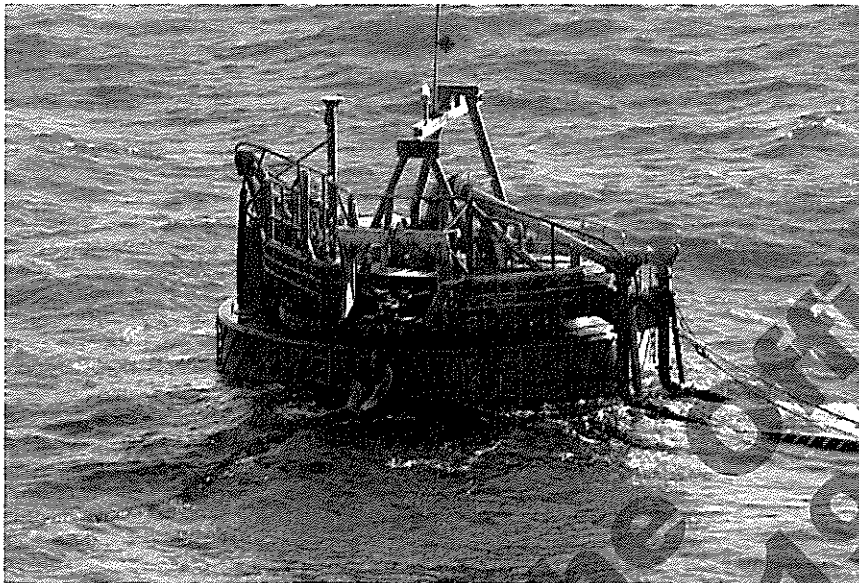
Figure 4.3 – The Taharoa CALM Buoy Afloat

3. The Taharoa SBM is 38 years old, was built to approved drawings, but has never been maintained in 'class'. It is in a fair condition, but is considered to require significant improvements to the inspection and maintenance regime to continue to be operated for the future Taharoa operations. Particular focus is required on fatigue sensitive components.

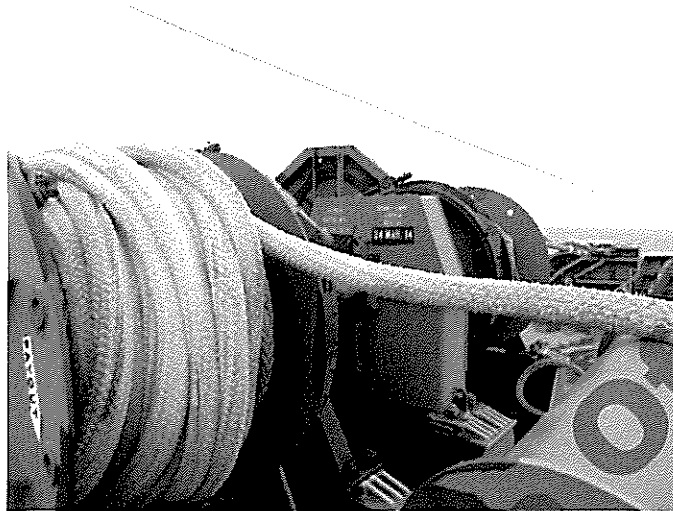
Figure 10.2 - Hawser Messenger on Winch Drum Bunching

10.1.5 When the hawser eye was between the waterline and the centre lead we noted that the winch drum was nearly full, with the risk of turns riding over the side of the drum. We also noted that the winch was slightly off-centre with the centre fairlead, which would account for bunching up on the winch drum (Figure 10.2). Crew members intervened on at least two occasions to push and pull the messenger one way or the other to prevent it overriding the side of the drum. Although there was only the weight of the partially raised hawser on the messenger line, we consider that this requirement to pull, push and guide the messenger on to the drum by hand was a high risk operation. The main risk was not from the messenger parting, but from slipping or stumbling and getting a hand or arm trapped under the messenger while it was being heaved up.

10.1.6 There is also a high risk of a turn of rope riding over the edge of the winch drum and jamming up between the winch drum and the supporting frame. Depending on the severity of the jam, it can be anything from a minor inconvenience to a major operation requiring tools and knowledge of how to clear the jam. The winch would be immobilised and hence, if the ship drops back or off the wind, all the weight could come on the messenger, which would part under that sort of strain. Unless the crew had been warned and cleared from the whole area, there would be a very high risk of serious injury or fatality resulting from the recoil or snap-back. See section 10.3 for recommendations for improvement.
