TAHAROA

Inspection and Audit of Port Taharoa Operations

Date: 16 July 2015

Our Reference: CW/812/R01/NC/SLB

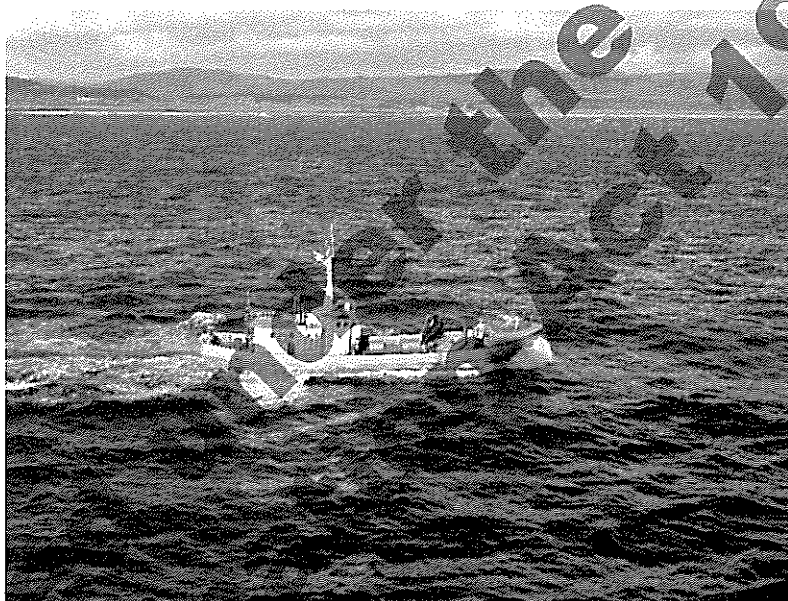
9.1.2 We boarded the support vessel "MARGARET J" (MJ), met the Skipper and several of the deckhands and made a short tour of the vessel. The "MJ" is a steel hulled converted fishing vessel with a raised forecastle (see Figure 9.1).

Figure 9.1 - The "MARGARET J" working off-shore Taharoa

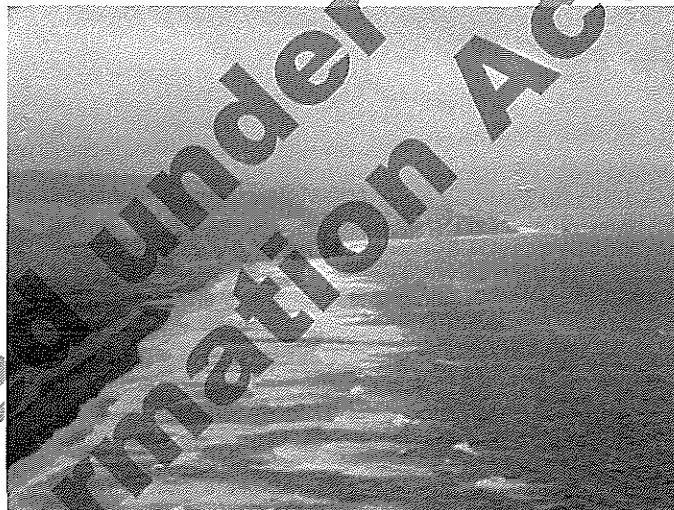
10.1.2 We remained on the bridge to observe the approach manoeuvre up to about 500 metres from the buoy, when we proceeded forward to observe the hawser pick up operation. While on the bridge we took the opportunity of measuring the depth of the surf line, which was clearly visible on the Radar, using the variable range marker. We measured this to be 0.268 nautical miles, or 500 metres in extent (see Figure 10.1).

Figure 10.1 - 500 metre Surf Line at Taharoa

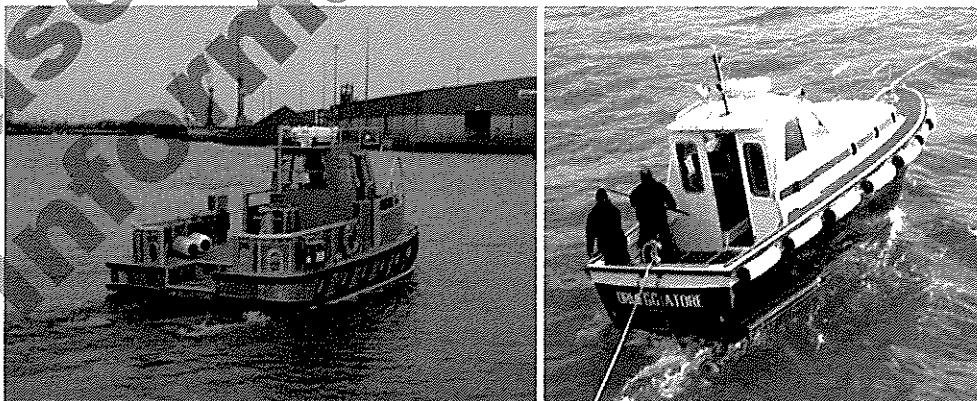
10.2.18 During the whole operation of hawser and slurry pipe pick up and letting go, we were able to observe the "MJ's" 'zodiac' at work. The crew are highly skilled and obviously very used to this kind of close-quarters work with lines and hawsers. However, as a line-handling boat and helicopter stand-by rescue boat, we consider that it is totally unsuitable. For such an exposed and potentially hostile location, we consider that it is too small and too light to provide a sufficiently stable platform to its crew, and provides no protection from the sea or elements. It has minimal rescue capabilities, and has an outboard motor with an exposed propeller which would render it extremely hazardous to any persons in the water.

Figure 10.17 – Typical Offshore Line Handling Boats

10.2.19 Figure 10.17 shows some examples of typical line-handling vessels employed at offshore terminals.
